## WELL LOG AND DRILLING REPORT

State of Ohio

DEPARTMENT OF NATURAL RESOURCES

No. 234564

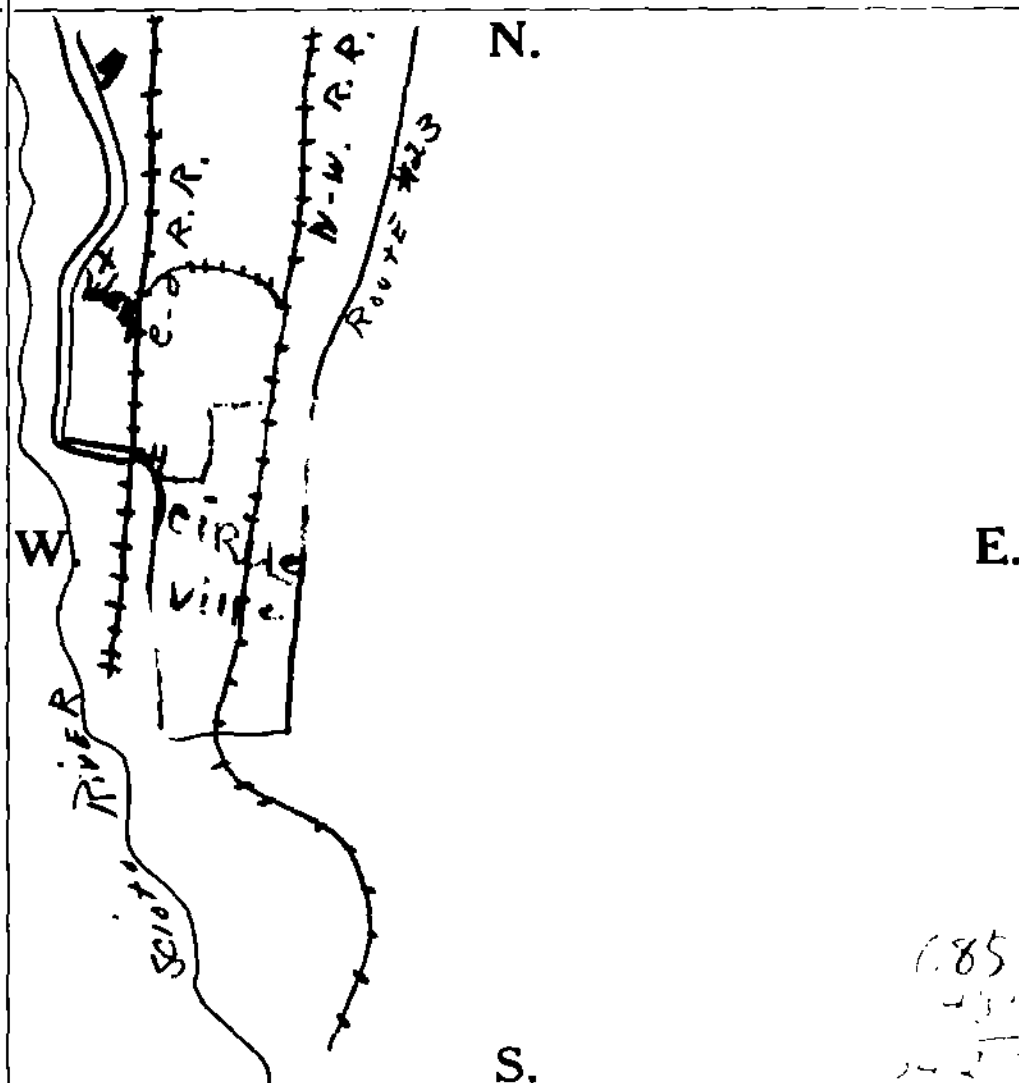
## SKETCH SHOWING LOCATION

County Pickaway Township Circleville Section of Township           
 Owner Ralph H. Dresbach Address Circleville, Ohio  
 Location of property Sturm & DILLARD ~~Prop~~ property on Island Rd.  
Wall on EAST SIDE of ROAD

Locate in reference to numbered  
State Highways, St. Intersections, County roads, etc.
