# WELL LOG AND DRILLING REPORT

State of Ohio  
DEPARTMENT OF NATURAL RESOURCES  
Division of Water  
1562 W. First Avenue  
Columbus, Ohio

No. 235811

Owner J. B. Connor Address Rt 1 Leesburg, Ohio

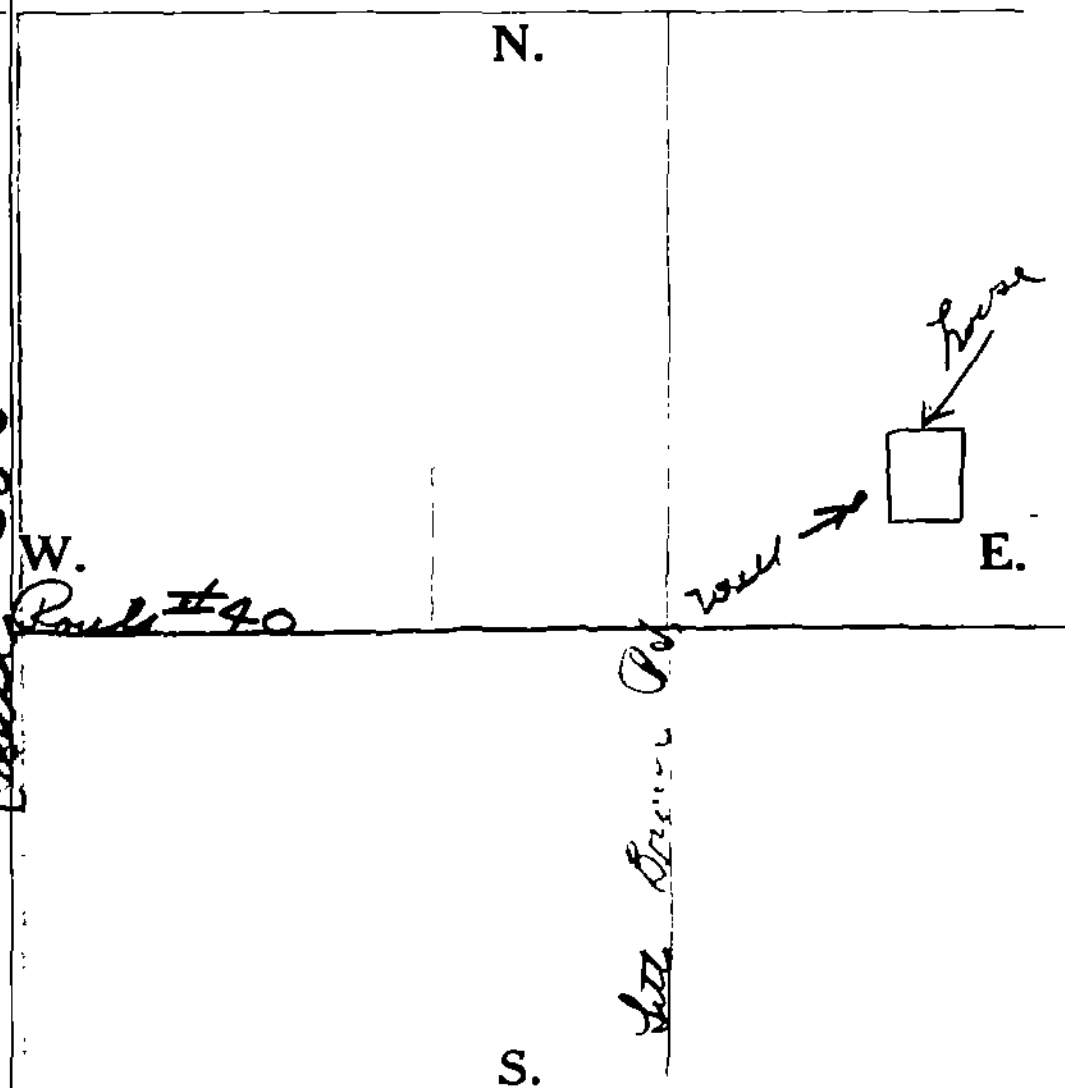
## SKETCH SHOWING LOCATION

Location of property Northeast side of Rt 40 - 200 ft East of Rd. Side Park 1 1/4 Mi. East of Leesburg

Locate in reference to numbered  
State Highways, St. Intersections, County roads, etc.
